Manhole Inspection Summary

Manhole # S13GG1024MH

Location Address: **PAEK HEIGHTS AVE**

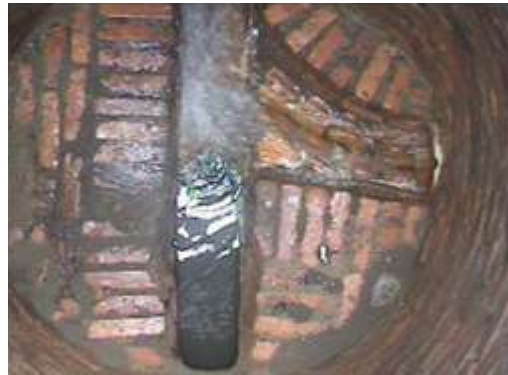
Top View

Count: **2** Missing: **2** ☒ **Corroded**

CORRODED / MISSING RUNG

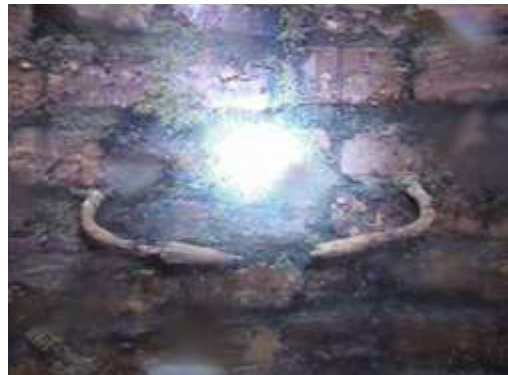
Defect 1

CORRODED / MISSING RUNG

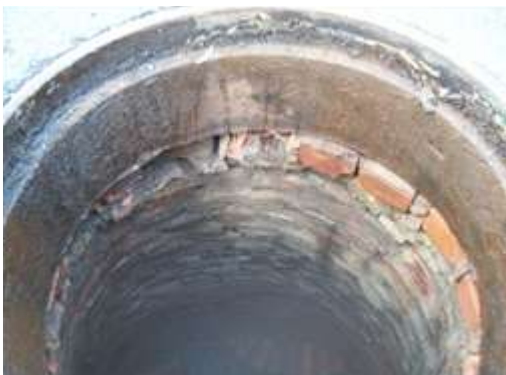
Defect 2

Condition: ☐ Sound ☐ Cracked ☐ Root Intrusion ☒ **Loose Brick** ☒ **Deteriorated**

LOOSE bricks and deteriorated CORBLE

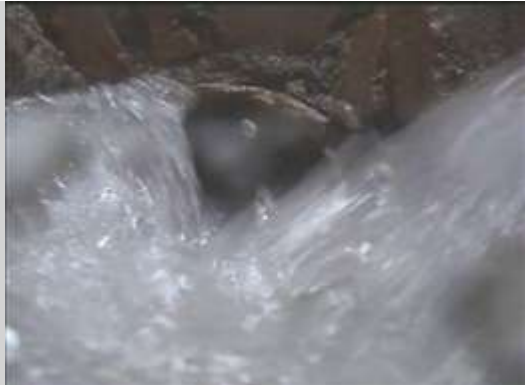
12 O'Clock Outflow

8 in. Circular Gravity Sewer
Pipe Out @ 12 O'Clock

Invert Depth: **7.77** (ft.) Flow Characteristics: **Turbulent**

Infiltration: **None** Pipe Seal Cond: **Sound**

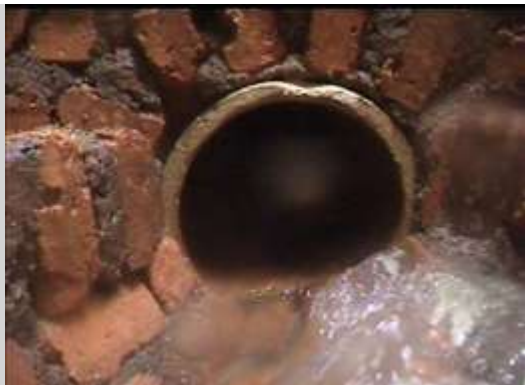
3 O'Clock Inflow

8 in. Circular Gravity Sewer
Pipe In @ 3 O'Clock

Invert Depth: **7.36** (ft.) Flow Characteristics: **Fast**

Infiltration: **None** Pipe Seal Cond: **Cracked**

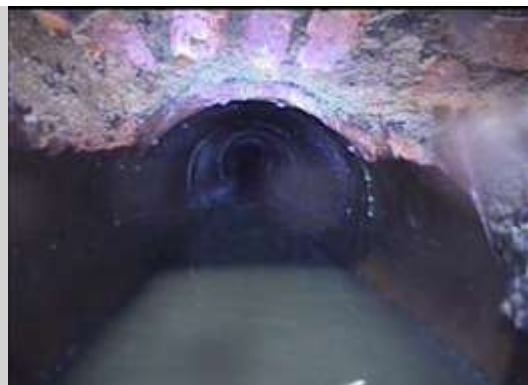
6 O'Clock Inflow

8 in. Circular Gravity Sewer
Pipe In @ 6 O'Clock

Invert Depth: **7.62** (ft.) Flow Characteristics: **Slow**

Infiltration: **None** Pipe Seal Cond: **Sound**
